RARITAN RIVER BASIN  
NORTH BRANCH RARITAN RIVER  
SOMERSET COUNTY  
NEW JERSEY

# RAVINE LAKE DAM NJ 00362

## PHASE 1 INSPECTION REPORT NATIONAL DAM SAFETY PROGRAM

May, 1979

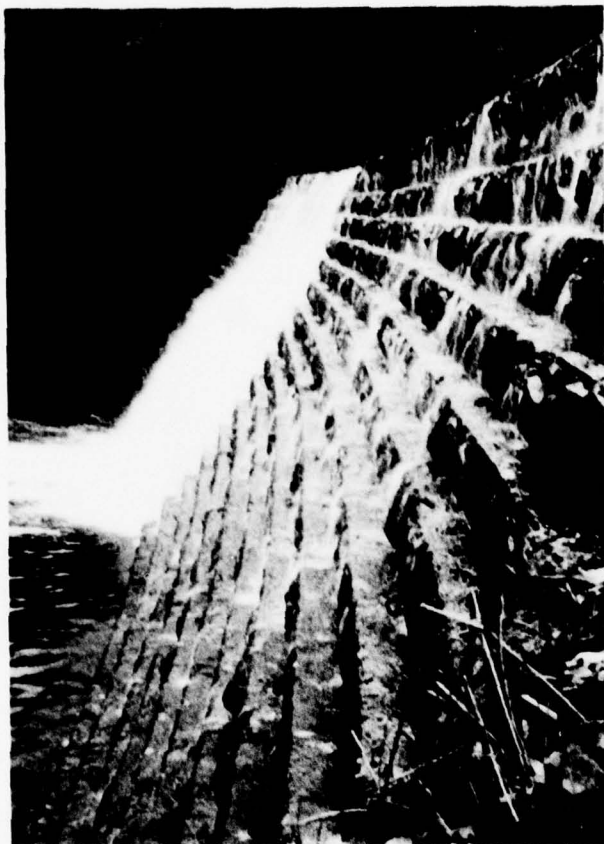
The dam was inspected for signs of settlement, seepage, spalling, cracking and any other evidence of undesirable behavior which might affect the stability of the structure. Because water was flowing over the entire length of spillway, much of the downstream face of the dam was not accessible for inspection (Photo 1).

Photo 1 - Downstream  
face of dam looking  
west.  
(December 4, 1978)

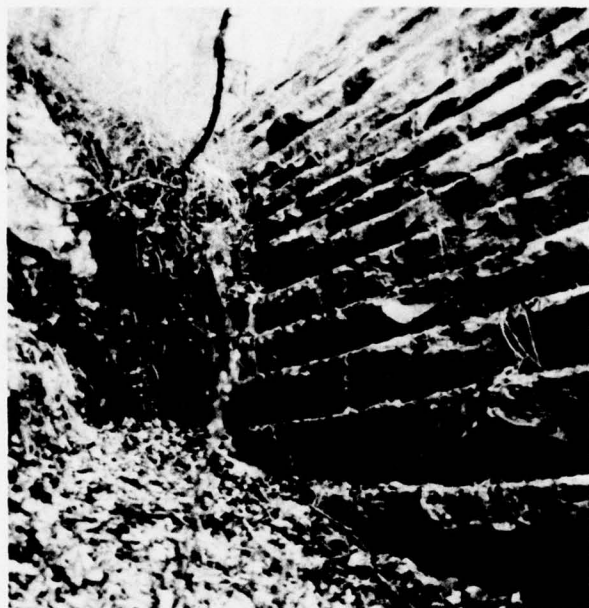
At the junction of the dam and the right abutment there was seepage of about 3 gpm at a point 11 feet below the dam crest (Photo 3). The seepage appears to be originating in the abutment and probably represents flow through joints or fractures in the bedrock.

Photo 3 - Seepage at  
right abutment causing  
iron-stained mineral  
deposits.  
(December 4, 1978)

(2) Repair leaks in the dam and seepage in the right abutment. Replace loose mortar.

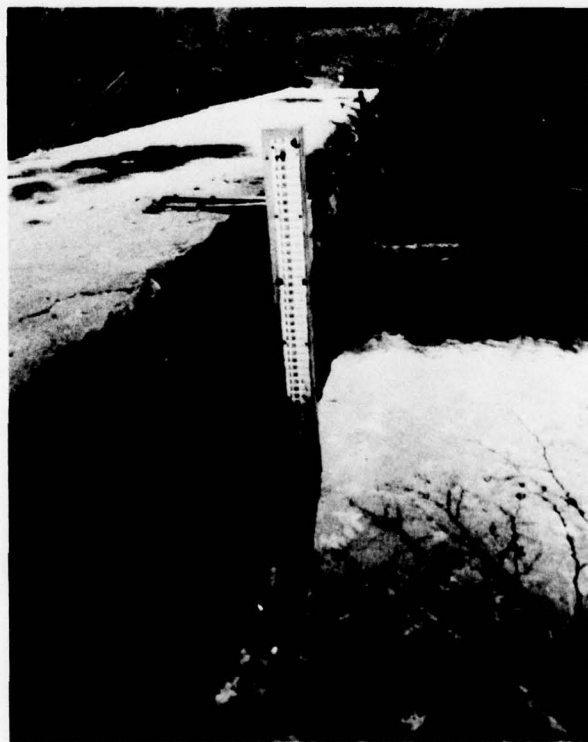
Little of the upstream face of the dam was visible. The mortar on the uncoursed rubble wall appeared to be sound, insofar as could be observed (Photo 4).

Photo 4 - Upstream left  
side of dam, showing  
uncoursed rubble masonry,  
staff gage and log boom  
above intake structure.  
(December 4, 1978)

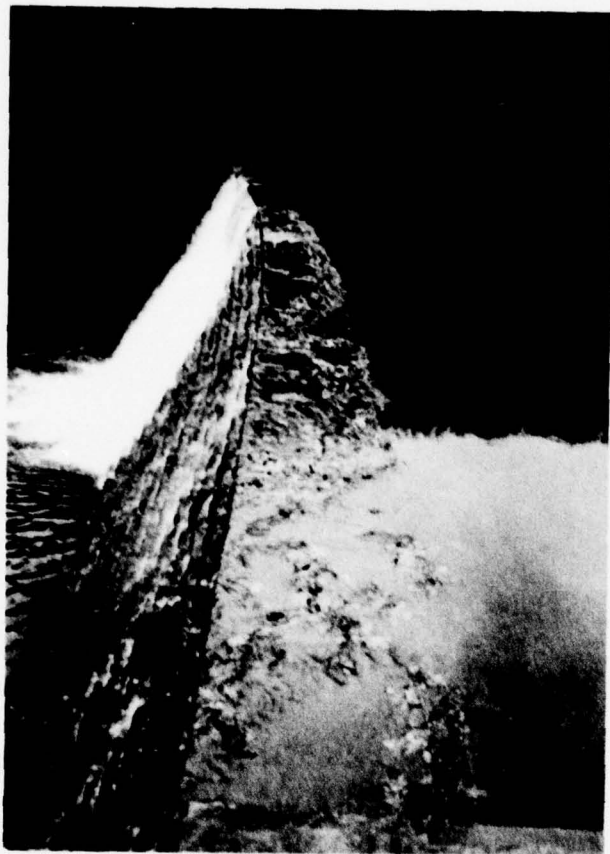
At the time of inspection the major flow of water was through the depressed central section of the spillway, with lesser flow over the storm overflow sections on either side. Although it was not possible to closely inspect the spillway, the uniform flow of water indicated that there were no major discontinuities or failures of the sill (Photo 5).

Photo 5 - View of  
spillway looking west.  
(December 4, 1978)

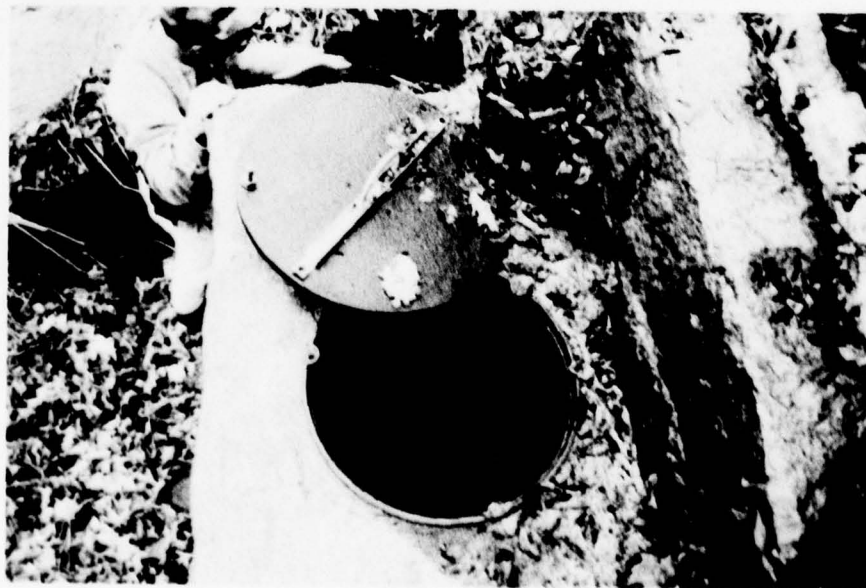
The manhole housing the 6-inch outlet valve on the left side of the dam was dry and appeared to be in satisfactory condition (Photo 6). A log boom is installed over the inlet in the reservoir (Photo 4).

Photo 6 - Valve chamber for 6-inch outlet on  
left side of dam. (December 4, 1978)

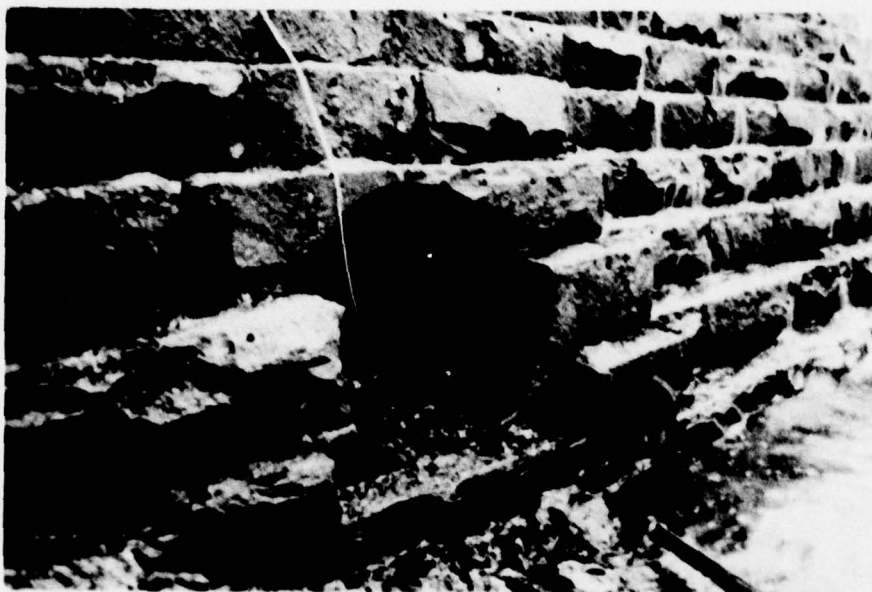
The 48-inch emergency outlet on the right side of the dam showed no indication of leakage (Photo 7). An 8-inch thick granite slab with a 4-inch diameter hole in

Photo 7 - 48-inch emergency outlet on right side of dam. (December 4, 1978)

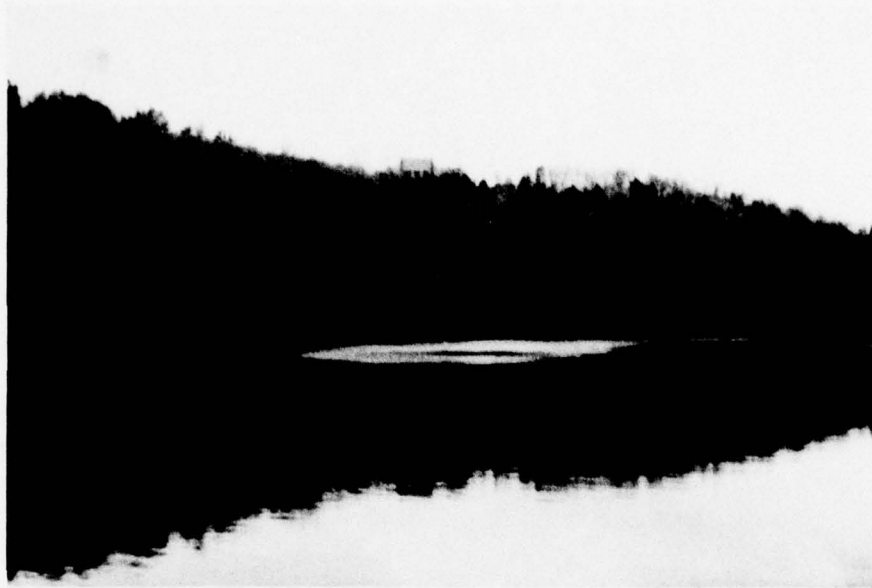
Water in the reservoir appeared to be clean and without odor. Only a minor amount of debris was noted, but the steep wooded slopes do afford debris potential (Photo 9). The slopes appear to be stable and there is no indication of previous slides. Some sedimentation was noted at the abutments. Previous reports indicate a siltation problem.

Photo 9 - Reservoir, looking toward west bank from dam. (December 4, 1978)

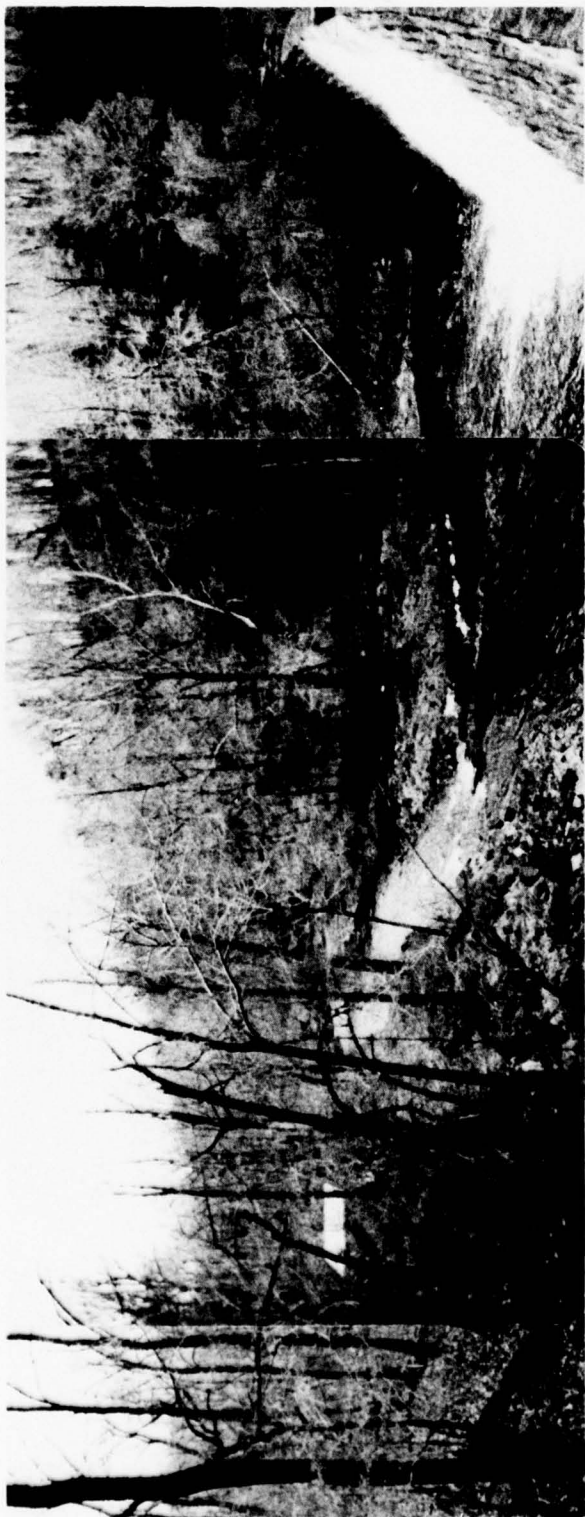
A stilling pool extends about 200 feet downstream of the dam. The river below the pool is slightly meandering and has a steep gradient (Photo 11). Slopes on the right bank are steep and wooded and those on the left bank are moderately steep. A bridge about  $\frac{1}{4}$  mile downstream has partially failed and 2 of the arched openings have been filled with gravel (Photo 12). Several houses are located on the left bank near this bridge.

Photo 11 - Stilling pool and downstream channel.  
Pump house on left bank. (December 4, 1978)

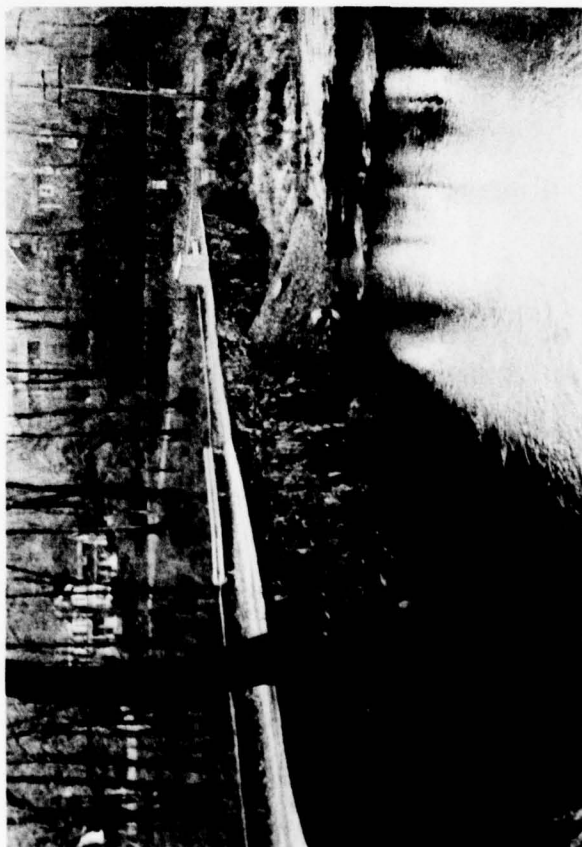
Photo 12 - Bridge and houses  $\frac{1}{4}$  mile downstream.  
(December 4, 1978)
